Final Report

Innovative Cattle Heavy Use Area Protection Using Wood Chip Surface a Pennsylvania Chesapeake Bay Conservation Innovation Grant – FY 2018

Bradford County Conservation District

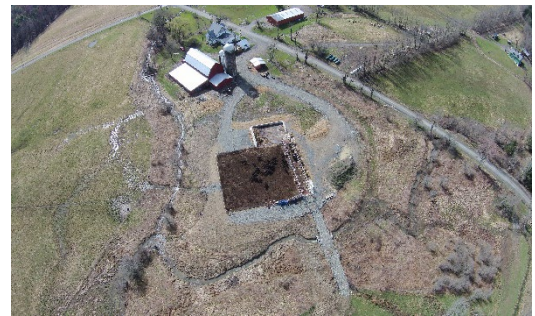
Aerial view of completed project (4/17/2019). Previous unimproved holding area was in the same location.

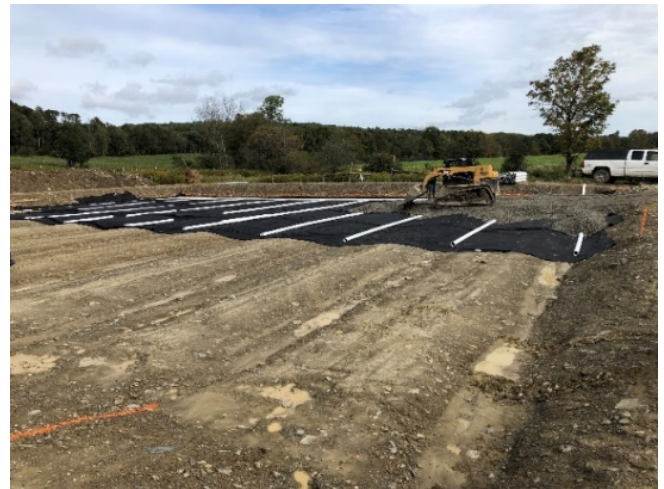
Subgrade shaped in ridge and valley pattern to expedite drainage.

The site chosen was on high clay content soils suitable for an impermeable subgrade. A perimeter drain was installed around three sides to lower the seasonal-high water table. An impermeable subgrade is necessary to protect ground water and to contain nutrients for collection and utilization. To best fit the site, the pad subgrade (and wood chip surface) slopes 1.0% - 2.0% toward the low point where all effluent ends up in one pipe. We believe this slope is not required but improves drainage efficiency. To maximize drainage from the pad, the subgrade was constructed with a ridge-and-valley pattern at 10-foot intervals, with a run of perforated drainpipe to be placed in each “valley”.

Construction began by stockpiling topsoil and organic matter. The pad site was excavated to grade achieving a flat area with elevations matching what would become the “valley” elevations of the undulating subgrade. Clay soil was then compacted in six-inch lifts around the perimeter constructing a berm to contain all effluent. The berm was built to an elevation six inches higher than finished wood chips. Six-inch high “ridges” were then built into the subgrade by carrying in clay soil with a skid steer and tracking the raised areas into place. After much discussion about how best to construct the undulating subgrade, the contractor reported that this method was indeed best. After all soil was in place, the entire subgrade was rolled with a light, smooth drum roller to help seal and smooth the surface. Geotextile (ADS 8 oz non-woven) was placed over the entire subgrade for weight distribution and to maintain separation between drainage materials and the clay subgrade.

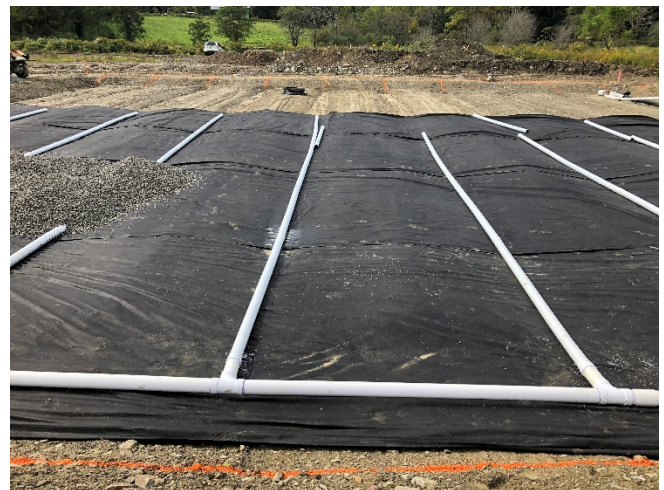
Geotextile placed over subgrade, under perforated pipes. Along bottom of photo is the solid PVC collection pipe, placed at -1.0% grade from left to right.

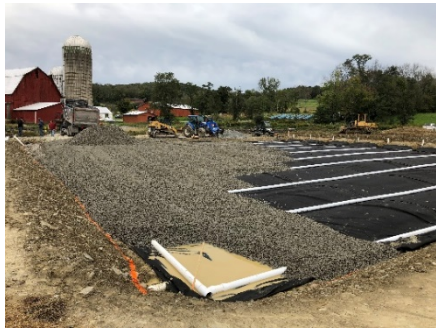
Clean #57 stone being placed over perf. pipe.

On top of the perforated pipe is placed 18" of clean, AASHTO #57 (2B) stone. Maximum depth of stone is 18 inches, so there is approximately 12 inches of stone over top of the ridges in the subgrade. The final stone surface slopes 1.0% - 2.0% exactly matching slopes of the subgrade. This stone was by far the largest material expense. Clean, #57 stone is considered essential for protection of pipes and longevity of drainage.

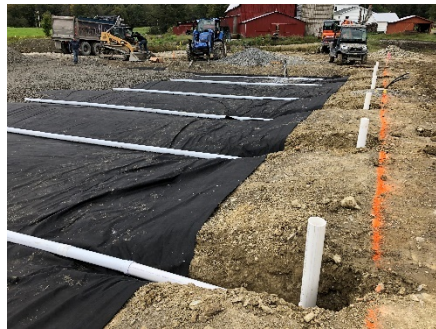
Clean-out at start of each perforated pipe.

The drainage system begins with the placement of 4" perforated pipe in each "valley" of the undulating subgrade. ADS 3000 Triple Wall pipe with two rows of perforations at 120 degrees apart was used. Perforations were placed facing down. Perforated pipes were sloping toward the manifold collection pipe at slopes varying from 1% to 2%, and the collection manifold pipe slopes at 1% to the low point of the subgrade. The manifold pipe then continues as solid schedule 40 PVC to the collection tank. Clean-outs were installed at the start of each perforated pipe run and at each end of the manifold collection pipe.

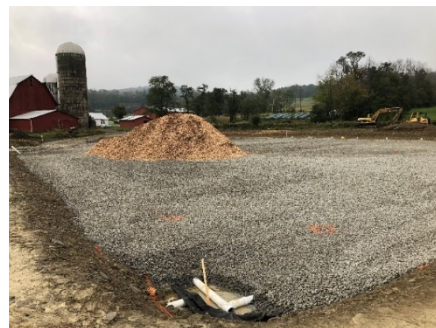
Ready to place wood chips atop #57 stone.

With pipes and drainage stone in place, a 12-inch thick layer of wood chips is placed directly on top of the stone. Since the stone surface ideally will never be reached or disturbed during annual wood chip maintenance, care was taken when placing wood chips to not disturb the leveled stone, maintaining a uniform wood chip-stone interface. The final wood chip surface slopes 1.0% - 2.0%, exactly matching slopes of the subgrade. This slope is not required. A finished surface with these slopes did not appear to cause migration of wood chips.

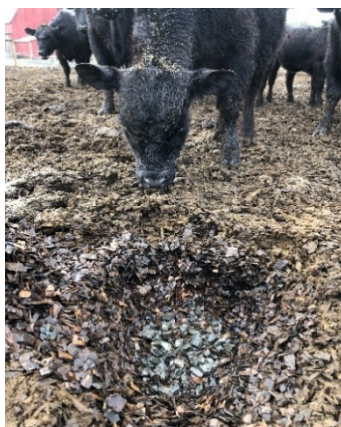
Wood chips soiled to 4" depth. Clean chips and stone beneath.

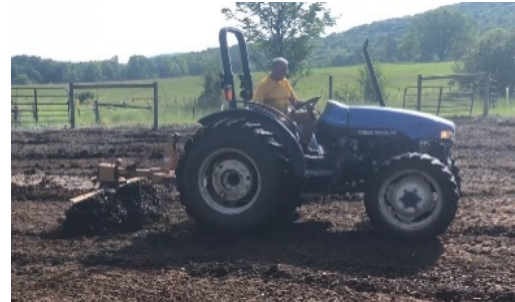
Six inches of soiled chips removed with back-blade.

The first confinement period ended May 17, 2019 when cattle went to pasture. Wood chip pad maintenance was performed July 4, 2019. Soiled wood chips were removed from the surface using a tractor and

back-blade, requiring the removal of approximately six inches of wood chips. Soiled wood chips were piled in the empty manure stacking area and remained until field application in November 2019. No efforts were made to stir the chip pile to encourage composting. Wood chips did not show significant signs of breakdown by the time of field application. New wood chips totaling 50 ton (200 yd³) were delivered in July and spread to bring the wood chip pad back to its original 12-inch thickness. The second confinement season began November 15, 2019. Cost of annual wood chip pad maintenance totaled \$3,180 which equates to \$32 - \$64/AU. Wood chip pad cleaning in the off season required a full day of detail work to separate soiled chips and prepare for re-surfacing. This level of management effort and interest will be essential for prolonging effective wood chip pad drainage.

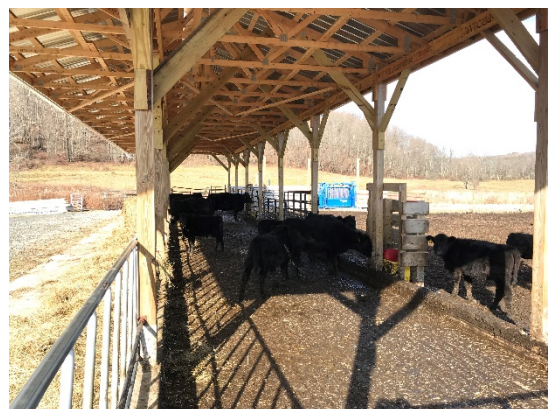
Concrete, covered feed lane adjacent to wood chip pad

Wherever this practice is used, feed and water must be provided on an adjacent, hardened area, where manure can be routinely removed. High manure concentrations at feed and water locations would overwhelm and eliminate drainage functions of the wood chip pad. The wood chip pad can be constructed adjacent to existing infrastructure for feed and water. In this case, existing facilities were inadequate, so a new concrete feed lane and adjacent manure stacking area were planned into the project. Design options of concrete feeding areas, waterers and manure storage are numerous and completely site specific. The feed lane was designed 12 feet wide and runs the entire 100-foot length of the wood chip pad. Cattle can enter and exit the feed lane along its entire length to minimize concentrated cattle traffic on the wood chips. Feed and water are only accessible when standing on the concrete. This is very important to minimize manure deposited on the chips. Feed is through slant bars along the curb opposite the wood chip pad. Waterers are placed on the wood chip pad side of the feed lane but are only accessible from the concrete. The feed lane is flanked by a 12-inch high curb along the feed manger and an 8-inch high curb along the wood chips which the cattle can easily step over. These have both been adequate to contain manure if the feed lane is cleaned regularly (two times per week). Manure is routinely scraped from the feed lane directly to the adjacent concrete manure stacking pad. The manure stacking pad was conservatively sized for 75% of the manure over a six-month period. Runoff from the concrete feed lane and manure stacking area drains into the wood chip pad for 100% containment of nutrients.

The system was designed to be completely uncovered. The eight-inch high feed lane curb along the wood chips was constructed with two-inch wide slots spaced 12 feet apart to allow water drainage from the feed lane into the wood chip pad. After the first confinement season, the farm installed a roof over the feed lane and feed manger. Along with feed efficiency, benefits of the roof include diverting clean water, dryer (more stackable) manure, and lower effluent volume. Roof water is collected and diverted from contact with manure using roof gutters and an underground outlet.

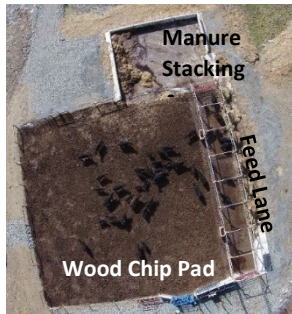
Wood chip pad on 4/17/19
(confinement day #108)
